**AQUATIC MONITORING REPORT FOR AQUATIC SAMPLE  
SITE BRFK-4 LOCATED NEAR ROARING FORK IN WISE  
COUNTY, VIRGINIA**

**Prepared for:  
Red River Coal Company, Inc**

**ATS PROJECT NO. 1199.01**

**August 2015**

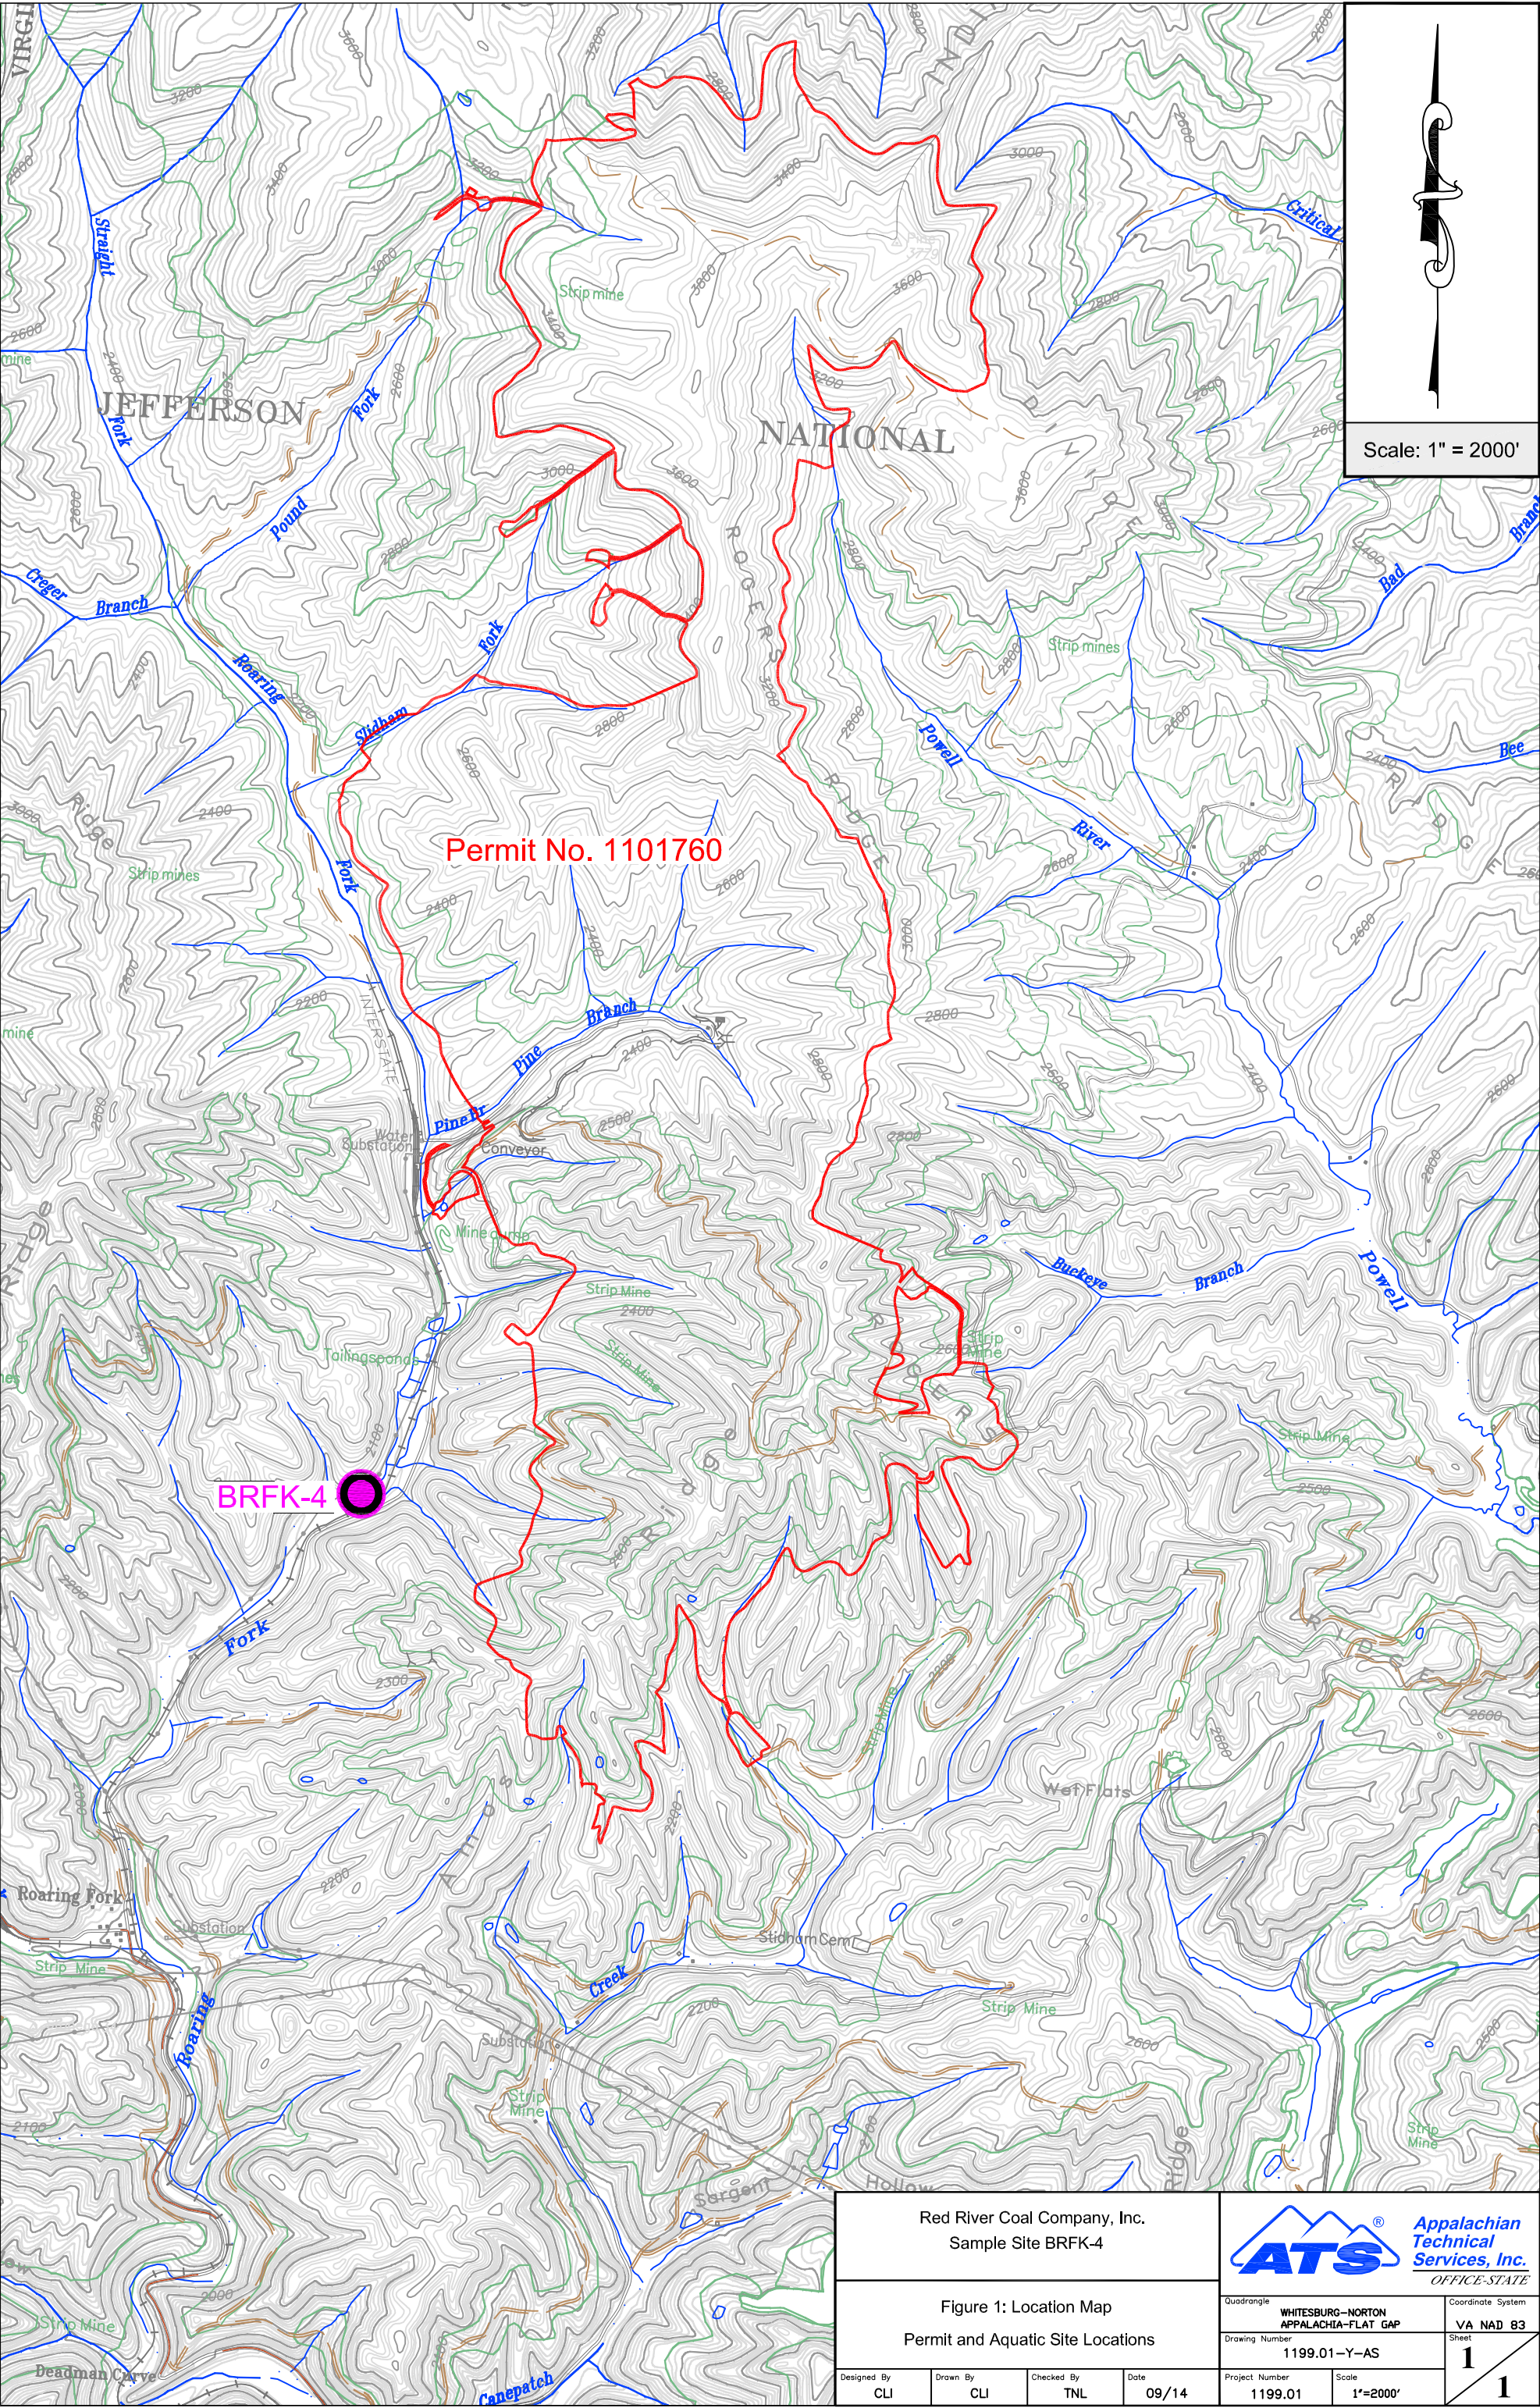
Appalachian Technical Services, Inc. was contracted by Red River Coal Company, Inc. to conduct aquatic monitoring near Roaring Fork in Wise County, Virginia. This report represents the fall 2015 aquatic biological assessment of aquatic sample site BRFK-4. The permit boundary and sample site location are shown on the attached topographical map in Figure 1.

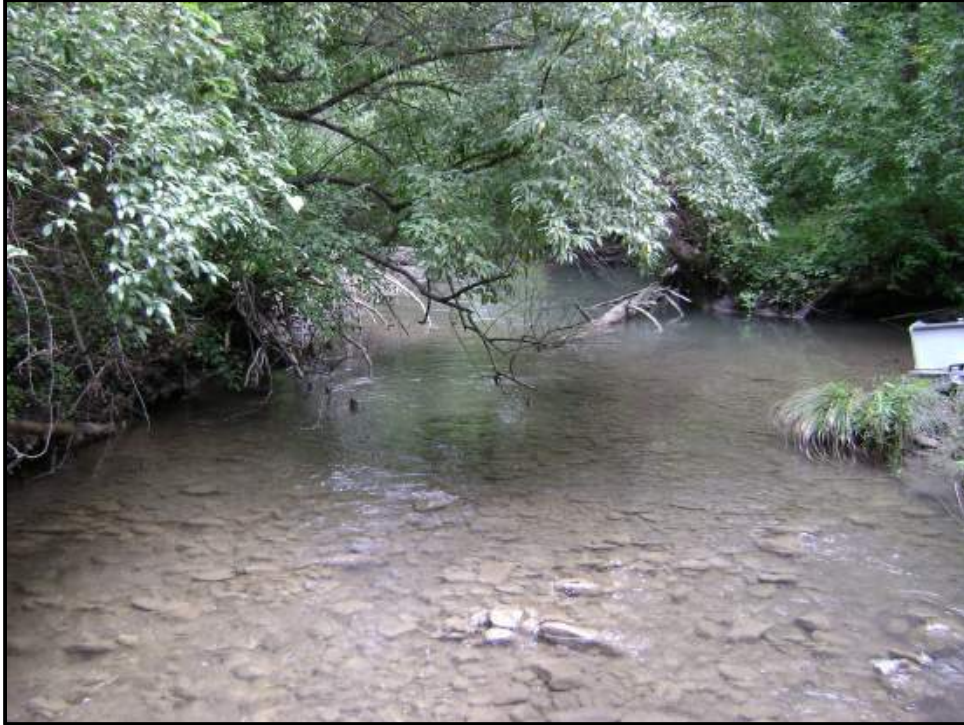
**Figure 2: BRFK-4 upstream view**

The stream habitat at BRFK-4 scored 139 of 200 (Appendix A), indicating the habitat is partially supporting its designated use. The stream was approximately 20 feet wide and characterized mostly by a series of riffles and runs (Figures 2 and 3). Flow occupied >75% of the stream channel. Embeddedness was suboptimal with 25 to 50% of the substrate particles surrounded by fine sediment. The water was clear but there was slight deposition of sediment within the streambed. The stream banks were stable and with good riparian zones.
